# Simulations of Erosion/Corrosion Surface Chemical Reactions with A Laser Beam

C. W. Price

November 1, 1983

Lawrence  
Livermore  
National  
Laboratory

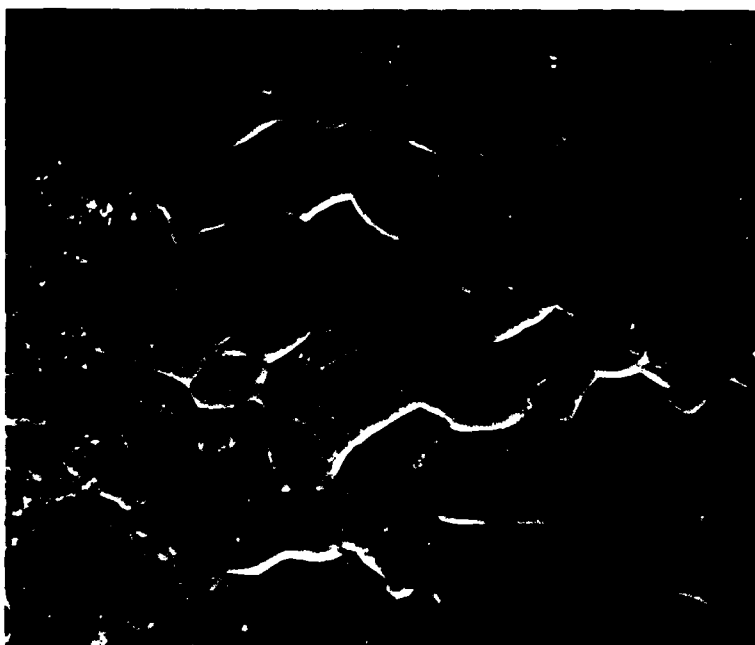
Fig. 22. Scanning electron micrographs of Iron B, 10 pulses in argon at 150 psi with a 40-J beam.

(a) Low-magnification view of the laser-affected region.

(b) Martensitic structure in the center of the melted region.

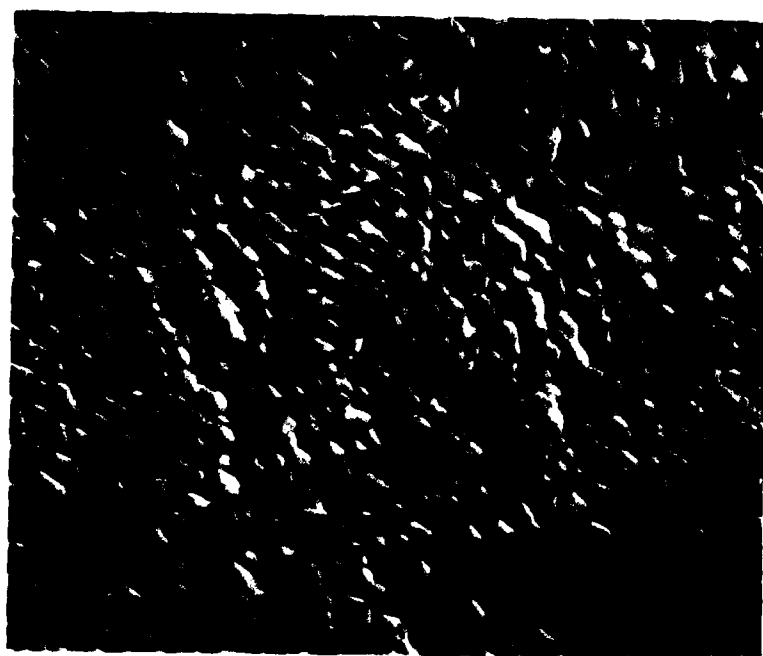
**Fig. 23. Scanning electron micrographs of Iron 70, 10 pulses in 10% methane/argon at 15 psi with a 40-J beam.**

**(a) Low-magnification view of the crater formed at low pressure.**

**(b) Evidence of surface melting in the center of the crater.**

**(c) Recrystallized structure at the outer edge of the rim with martensite platelets.**

**(d) Evidence of surface tearing on the rim.**

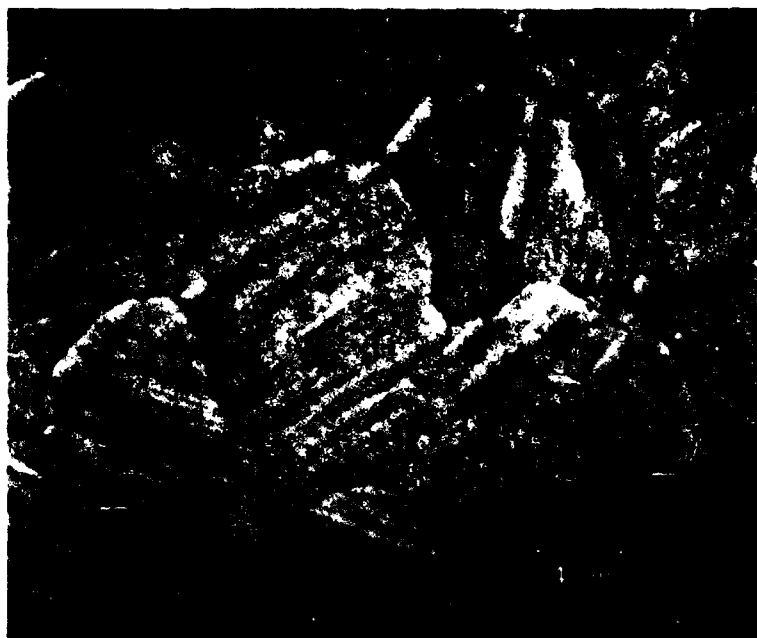
**Fig. 25. Comparison of surface melting in pure iron specimens after different numbers of pulses in 10% methane/argon at 150 psi with a 40-J beam.**

**(a) Iron 51, 2 pulses.**

**(b) Iron 52, 5 pulses.**

(c) Iron 54, 25 pulses.

(d) Iron 55, 50 pulses.

Structures from the melted regions of pure iron specimens that received from one to 50 pulses in 10% methane/argon are shown at intermediate magnifications in Fig. 24 and at higher magnification in Fig. 25. These specimens were laser-pulsed at 150 psi with a 40-J beam. Figure 24a is from Iron 50, which received one pulse, and shows only a recrystallized structure with a superimposed martensitic structure; no evidence of the globular structure was evident. The morphology of the crater definitely indicated that surface melting had occurred. Figure 24b, from Iron 51 which received two pulses, shows a similar structure with faint evidence of the globular structure. Figures 24c and 24d, from Iron 52 which received five pulses and Iron 55 which received 50 pulses, respectively, show well-developed globular structures. For purposes of comparison, additional examples of globular structures are shown at higher magnifications in Figs. 25a through 25d. In Fig. 25a, the globular structure appears to be in the initial stage of formation after two pulses. In Fig. 25b, the globular structure appears to be fairly well formed after five pulses. Figures 25c and 25d show that no further changes have occurred in the appearance of the globular structure after 25 and 50 pulses. These figures indicate that two to five

pulses were required to form the globular structure, and it remained fairly constant once it formed.

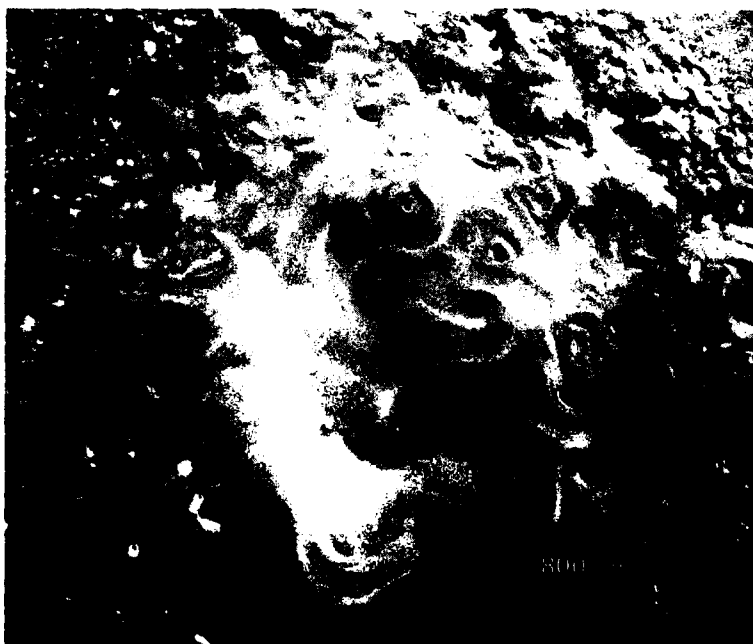
Fig. 28. Scanning electron micrographs of the laser-affected regions in AISI 4340 steel specimens after 10 pulses in argon at 150 psi.

(a) 4340 A, pulsed with a 10-J beam.

(b) 4340 B, pulsed with a 40-J beam.

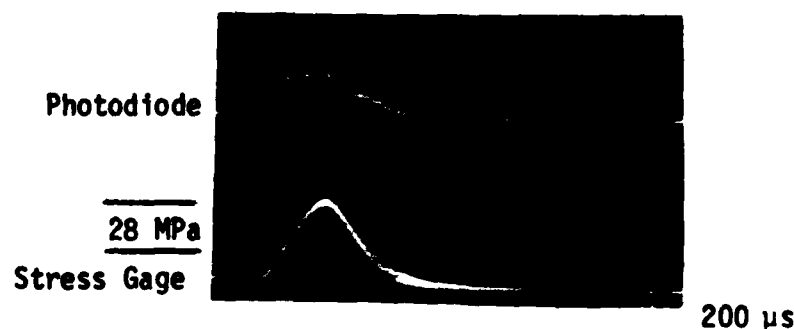
Fig. 9. Signal from piezoelectric ultrasonic stress gage resulting from normal mode laser deposition.
